Risk Assessment of an Existing  
School to the Effects from an  
LPG Vapor Cloud Explosion

Ray W. Anderson  
Agbabian Associates  
Pasadena, California

29 August 1990

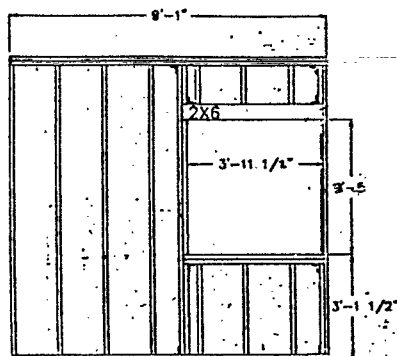
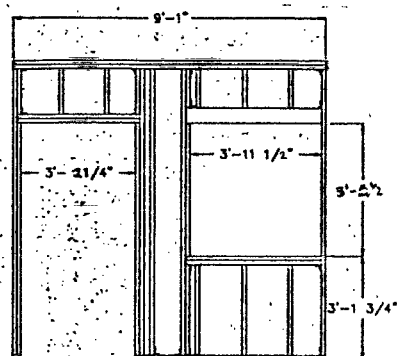
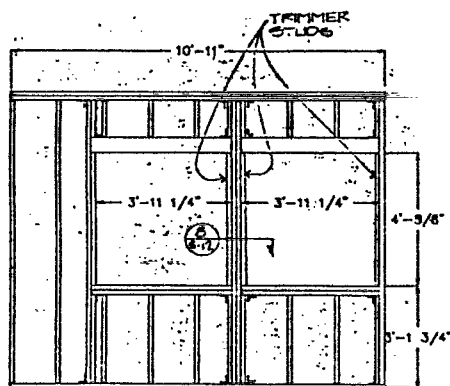
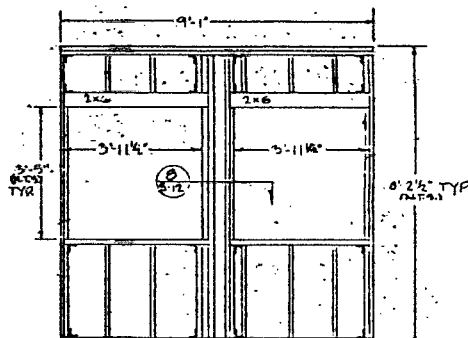
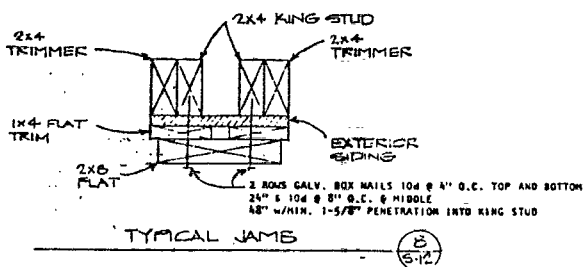
FIGURE 13. TYPICAL WALL FRAMING AT WINDOWS AND DOOR OPENINGS

Wall Framing for 10 Ft High Modules: The resistance of the 10 ft high side walls is limited to 0.31 psi because of the single stud used to frame a single window opening, as indicated in Figures 13a, 13b, and 13c. Double studs are used between two window openings when they occur in a single module, as indicated in Figure 13d, and they are reinforced with a flat 2 x 8 as shown in Figure 13e. Walls framed in this manner have a resistance of 0.74 psi. The resistance of the single-stud condition can be increased by nailing a flat 2 x 6 to the main and trimmer studs, in a manner similar to that shown in Figure 13e.

The single-stud framing condition at window openings in the area subjected to the reflected pressure should be reinforced using a flat 2 x 6 as discussed previously for similar situations.

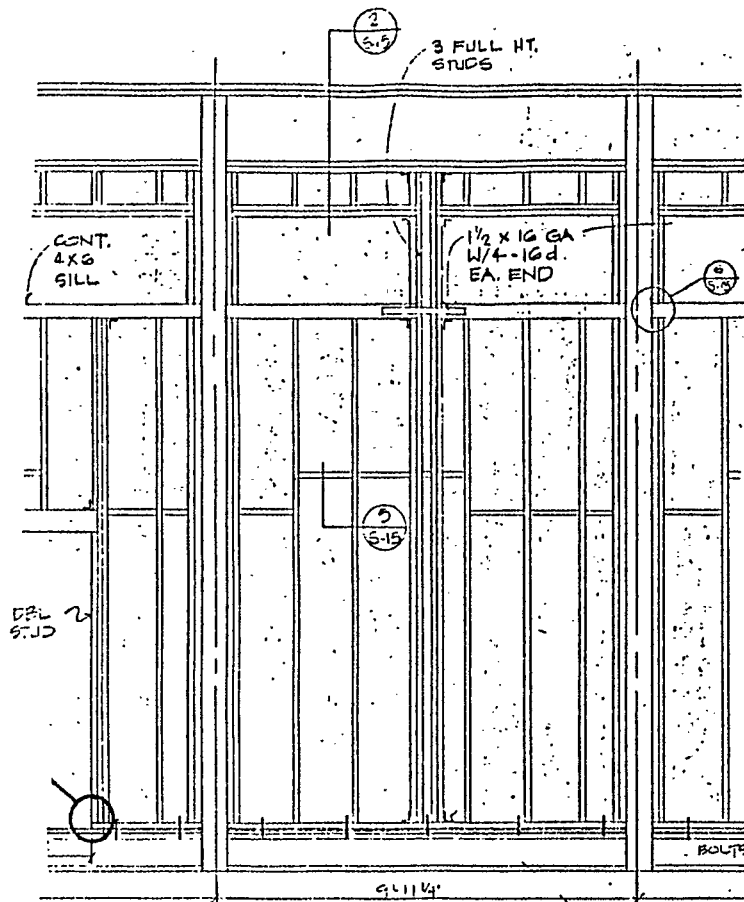
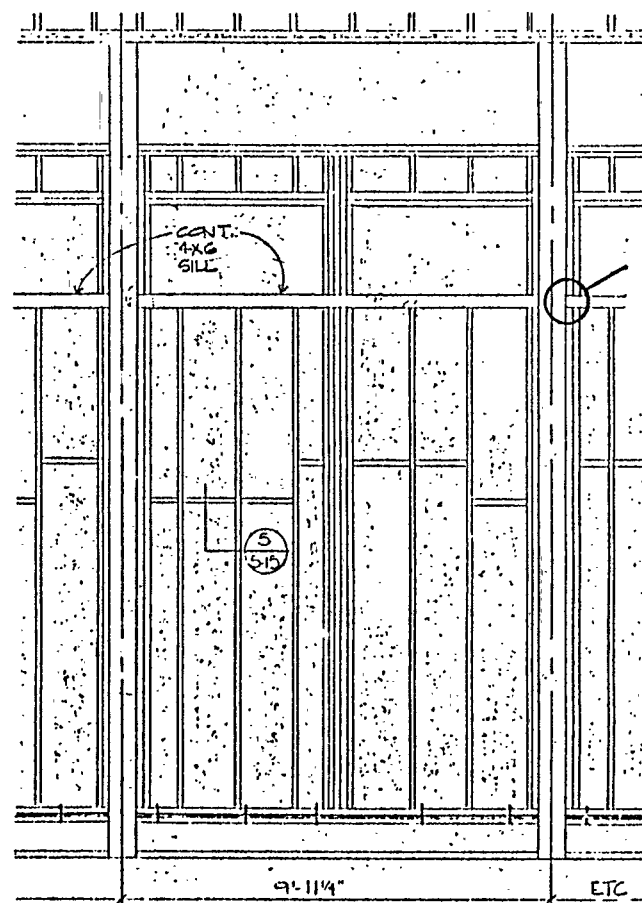
FIGURE 14. MULTIPURPOSE ROOM WALL FRAMING

Wall Framing for the 17-ft High Multipurpose Room: The typical 2 x 6 stud framing (no openings) resistance is at least 0.67 psi. However, the resistance of this continuous framing is limited to 0.46 psi by the bolted wall to steel member connection at the top and bottom, when considering reflected overpressure.

The framing for the north wall is not subjected to reflected overpressures and has a resistance of at least 0.61 psi. However, the south wall framing, because of differences in how the wall is framed for the window openings, is limited by the connection detail used to attach the window sills to the steel module corner columns. This occurs at 9 locations. See Figure 14 for difference in framing for north and south walls. The 1985 Uniform Building Code (UBC), Section 2506(d) and (e), requires that the strength of bolted joints in a wood connection be evaluated not only for the bolt or load but also as a notched beam, considering the notch to extend from unloaded edge of the member to the center of the nearest bolt. This requirement limits the resistance of the wall framing to 0.14 psi. The joint should be reviewed for its adequacy to resist the static design wind load of 15 psf (0.1 psi). In any event, the connection can be strengthened by connecting adjacent window sills with a long steel strap attached to the beams by lag screws. This is required at 9 locations.

The resistance of the multipurpose room is currently limited to 0.13 psi by the bolted connections in wood members framing the south wall that must be treated as notched beams. If these connections are brought up to code, the resistance of the multipurpose room will be at least 0.4 psi. To further increase the resistance of the multipurpose room, the wall bolted connections at top and bottom (resistance of 0.46 psi) and the bottom chord of the roof truss (resistance of 0.37 psi), require strengthening.
